Oundle North Bridge (Structure No 1093) is Grade II listed and comprises of 13 arch spans (both single and multi-span arches) in brick/stonework with stone headwalls/spandrels/voussiors/cutwaters and parapets.

PRINCIPAL INSPECTION 2018

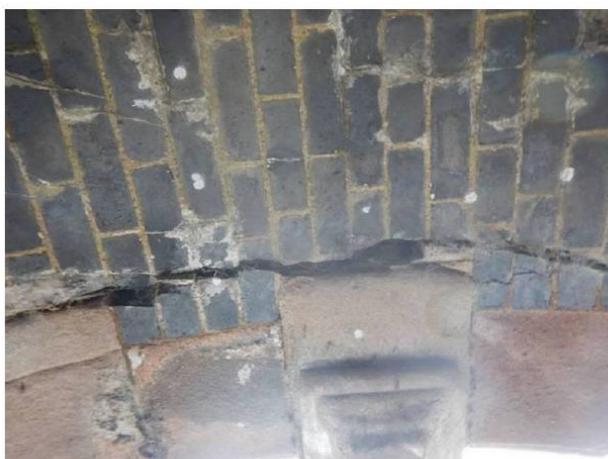
Crack between South Voussoirs and the masonry arch

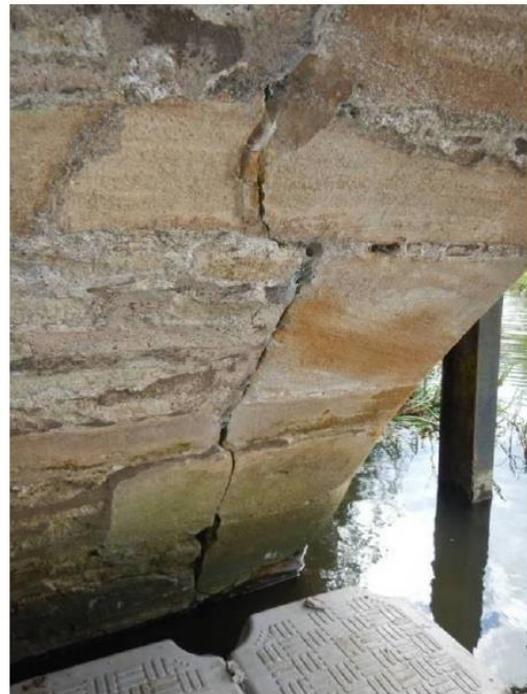
Crack in northern section of the arch

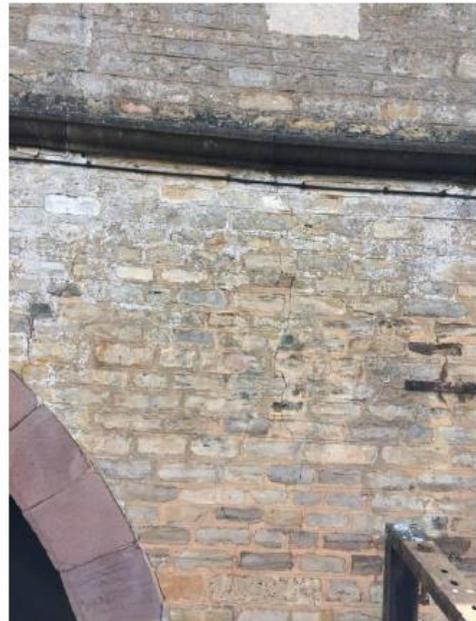
Cracking in spandrel wall between Arches 1 & 2. Note crack between the Voussoirs and spandrel wall

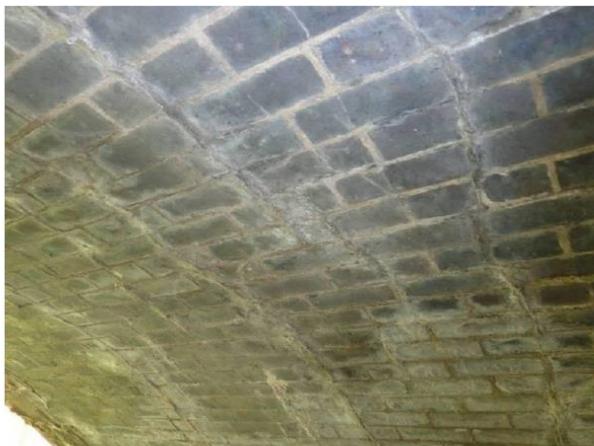
Cracking in barrel of the arch

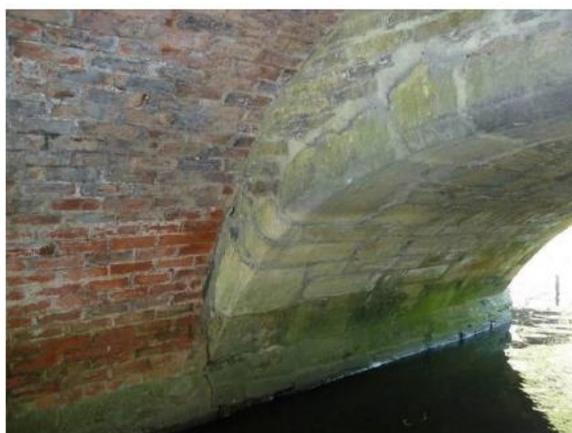
View showing junction between the north stone and the central 'red' brick sections

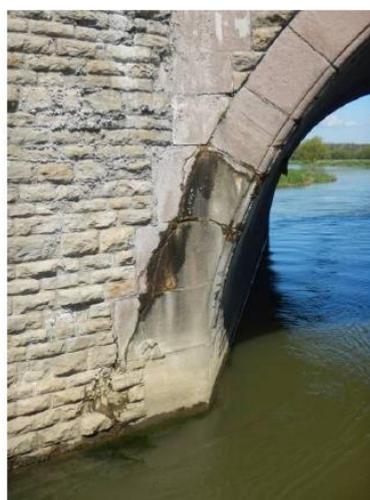
Crack between the northern voussoirs and the spandrel wall with evidence of water seepage
